Docket No. 217 – Development and Management Plan Inspection

Northeast Utilities Service Company Certificate of Environmental Compatibility and Public Need for the construction of a 345-kV electric transmission line and reconstruction of an existing 115-kV electric transmission line between Connecticut Light and Power Company's Plumtree Substation in Bethel, through the towns of Redding, Weston, and Wilton, and to the Norwalk Substation in Norwalk, Connecticut.

Date: July 19, 2005

Location: 345kV XLPE Component

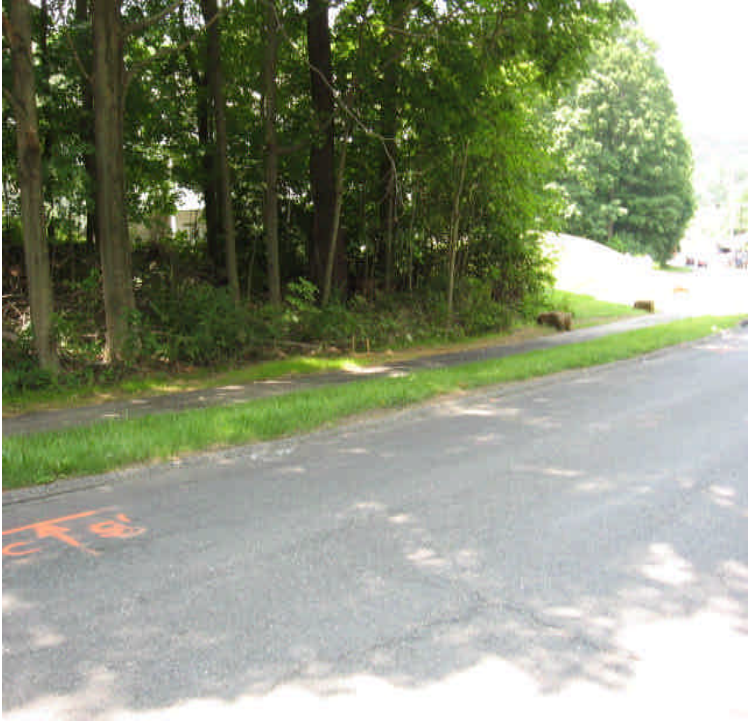
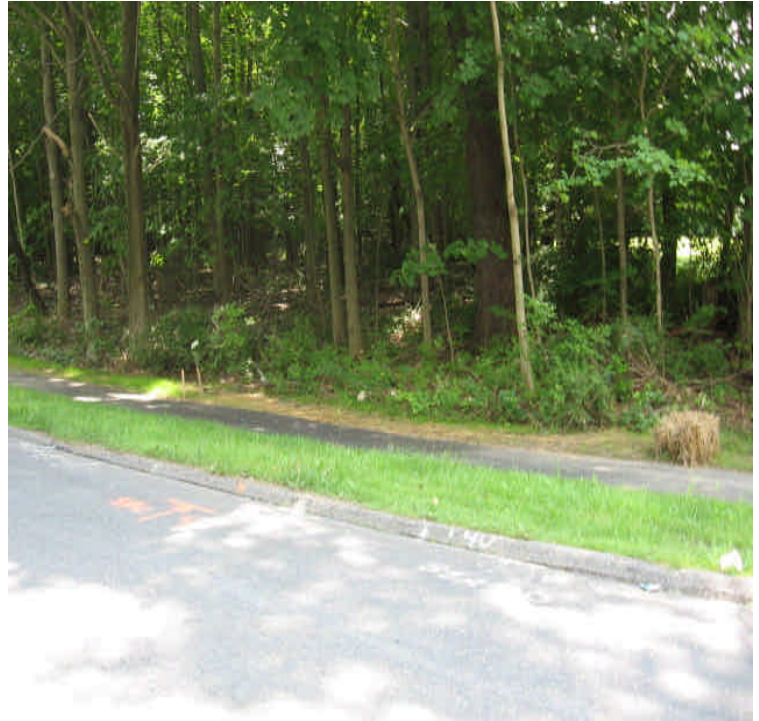
- Vault access continued to be noted on Rt 58 and along Whittlesey Dr. 7/12-7/19/06	- None at this time. 7/19/06	- N/A
	- The gully/ washout along the slope of Whittlesey Dr. was seeded and mulched and grass was noted. 7/19/06	-If the vegetation can continue to establish before significant rains, the area should stabilize. 7/12-7/19/06	- The washout was seeded and mulched.
	-Timber swamp mats were in place at the Hoyts Hill access off Rt. 58. This is not for 345kV XLPE work.6/20-7/19/06	- 345kV XLPE crews will restore the area and remove stone when applicable, following the	- Needs attention when work is complete.

345kV XLPE: Both photos show the slope along Whittlesey Drive where the erosion/washout along the sidewalk was repaired and reseeded. Some areas are beginning to show grass growth and are stabilizing. 7/19/06

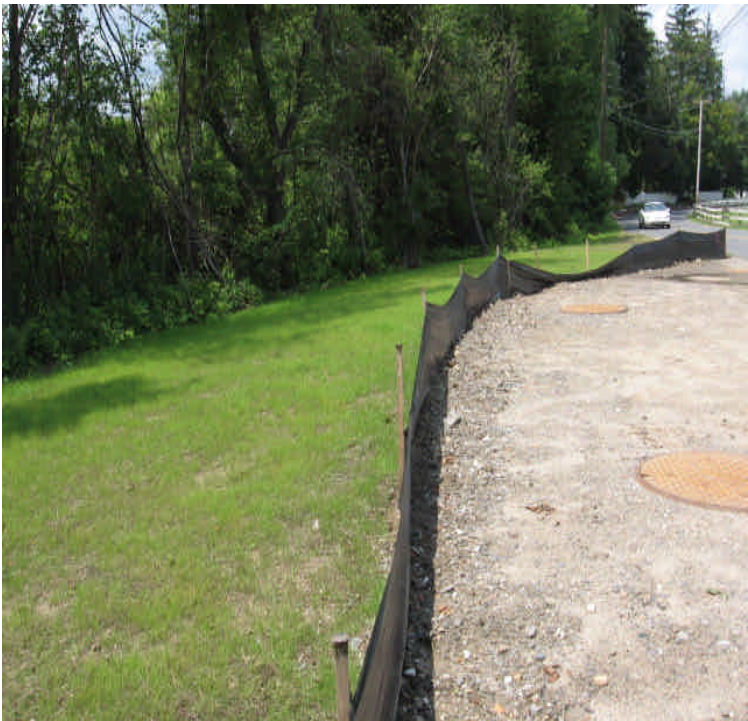
Photo on the left shows vault 2, with increasing vegetative cover establishing in the adjacent areas. Photo on the right shows equipment and materials for the jack and bore. These are being removed as the area is demobilized. 7/19/06

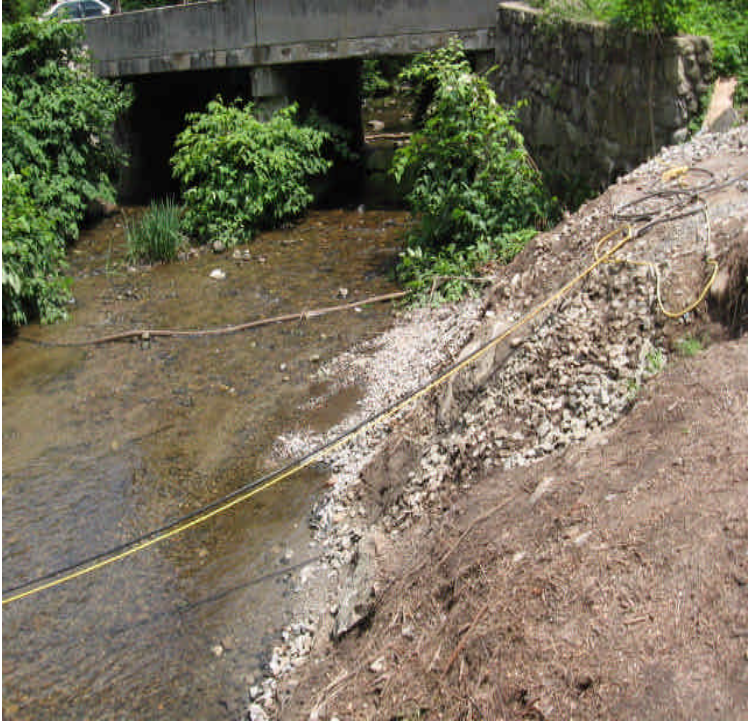
- Sandbags and liners have been removed from the banks as well as preparations are being made to restore the area. 7/19/06	-See erosion control section for restoration recommendations. 7/19/06	- N/A at this time

Photo on the left shows the streambank following removal of the sand bags and liners. The excess gravel will be removed and the banks will be seeded and mulched. Erosion control matting is being considered. Photo on the right shows the opposite bank. Silt fence should be extended until the sediment stockpiles are placed back into the trench. 7/19/06

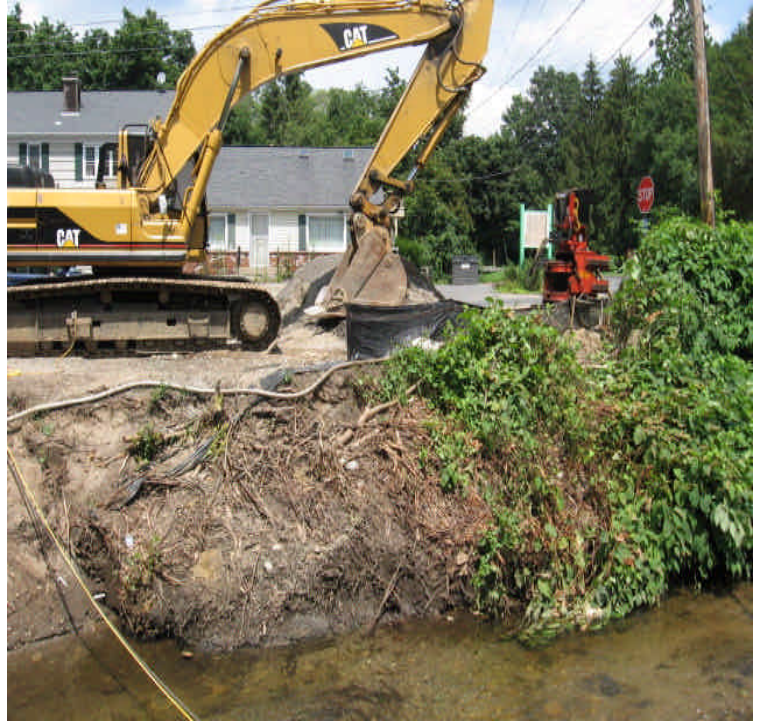
Areas of Inspection	Observation	Recommended Action	Corrective Action
	<p>- Some silt fence was up on a portion of the bank but a small stockpile pile was adjacent. 7/19/06</p> <p>- The sheet piling has been removed from the stream completely but remains up at the receiving pit. 7/19/06</p> <p>-Silt fence is up along the access to the stream in the ballpark entrance due to some tracks from the equipment. 7/5-7/19/06</p>	<p>stabilization. 7/19/06</p> <p>- The controls should be extended due to the stockpile. The dirt will be placed back in the receiving pit soon. 7/19/06</p> <p>-The stream was still running clear at the time and the bed has been restored. 7/19/06</p> <p>- None at this time. The area will be restored when work is complete. 7/5-7/12/06</p>	<p>- Needs attention</p> <p>- Sheet piling was removed</p> <p>-N/A at this time</p>
Whittlesey Dr and Judd Ave	<p>- The gully/ washout along the slope of Whittlesey Dr. was seeded and mulched and some grass growth was noted. 7/19/06</p>	<p>-Continue to monitor. If vegetation can establish before the next significant storm it should stabilize. 7/12-7/19/06</p>	<p>- Grass growth was noted.</p>

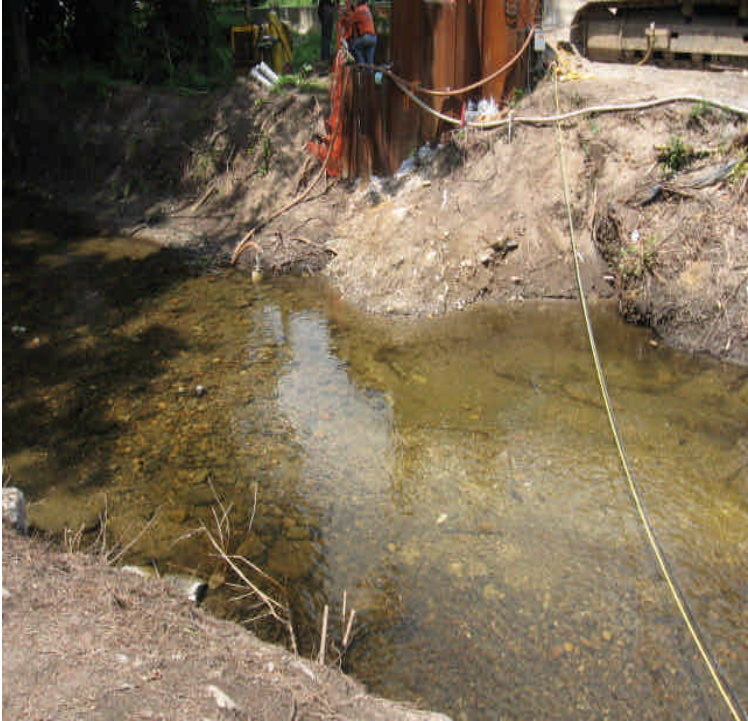
Photo on the left shows a view of the stream following the completion of the jack and bore under the channel. The water remains clear with a natural streambed. Photo on the right shows vault 5, which is one of the few remaining areas to restore. 7/19/06

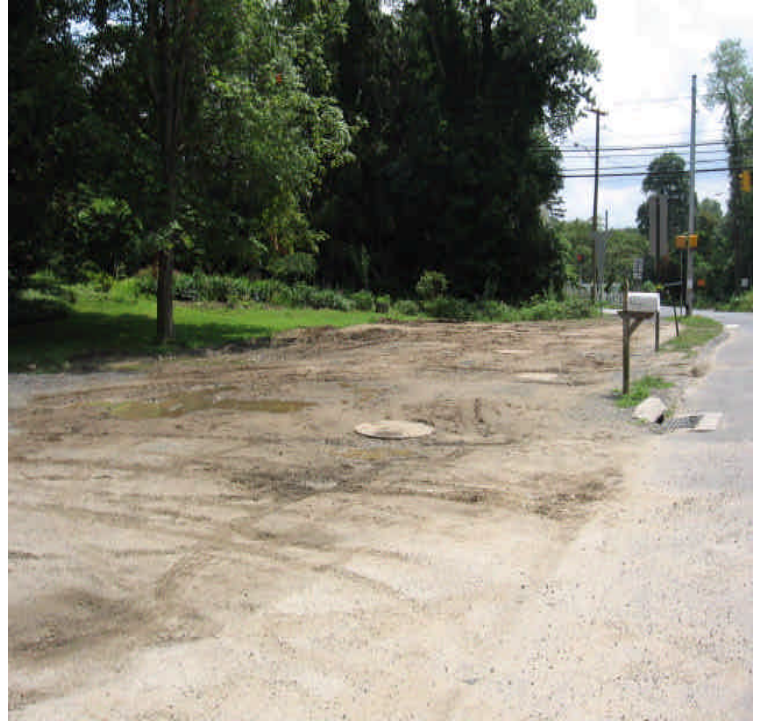
<p>- Vault access continues on previously restored areas and vault 5 is one of the few remaining areas to restore. 7/19/06</p>	<p>- Continue to monitor and restore as new access finishes up. 7/19/06</p>	<p>- N/A</p>
Hoyts Hill	<p>- Mats remain the base of slope at Hoyts Hill. Access is needed for other contractors pulling wire. 345kV crews will be restoring this area when access is complete. 7/5-7/19/06</p>	<p>-When access needs are complete, restore and allow wetland vegetation to return. All stone and gravel will have to be removed carefully and then high organic content soil should be placed here. Do not fill over the gravel. 7/5-7/19/06</p>	<p>-N/A until access is done.</p>
Inland Wetland and Watercourse encroachment and mitigation	<p>-Work in East Swamp Brook under ACOE clearance is almost complete. Sheet piling is removed and the</p>	<p>- Bank restoration remains. When the area is restored, make sure all excess gravel is removed and the banks are restored</p>	<p>-N/A at this time</p>
